Asbestos Flooring Location Listing

**RE: Limited Asbestos Inspection
Houston Central Campus
San Jacinto Building
1300 Holman Street
Houston, Texas, 77004
Envirotest Project Number: HOU 11 0122**

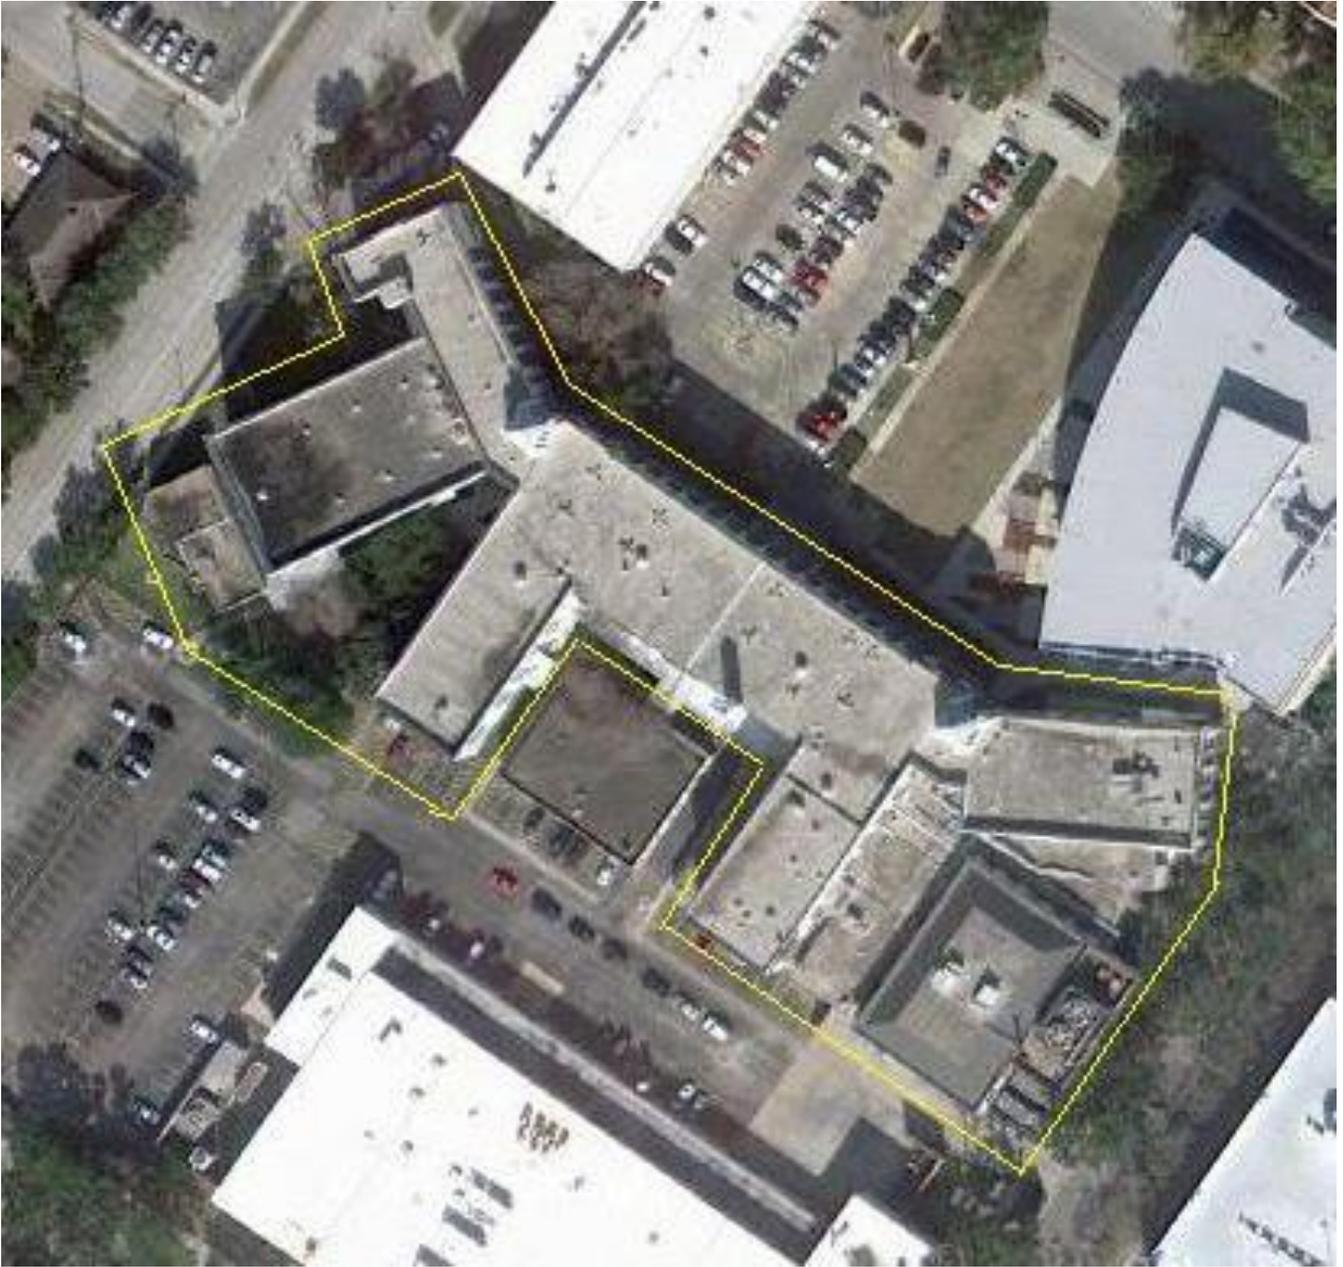
Building Site Plan Photo

San Jacinto Building Inspection Area is Outlined in Yellow

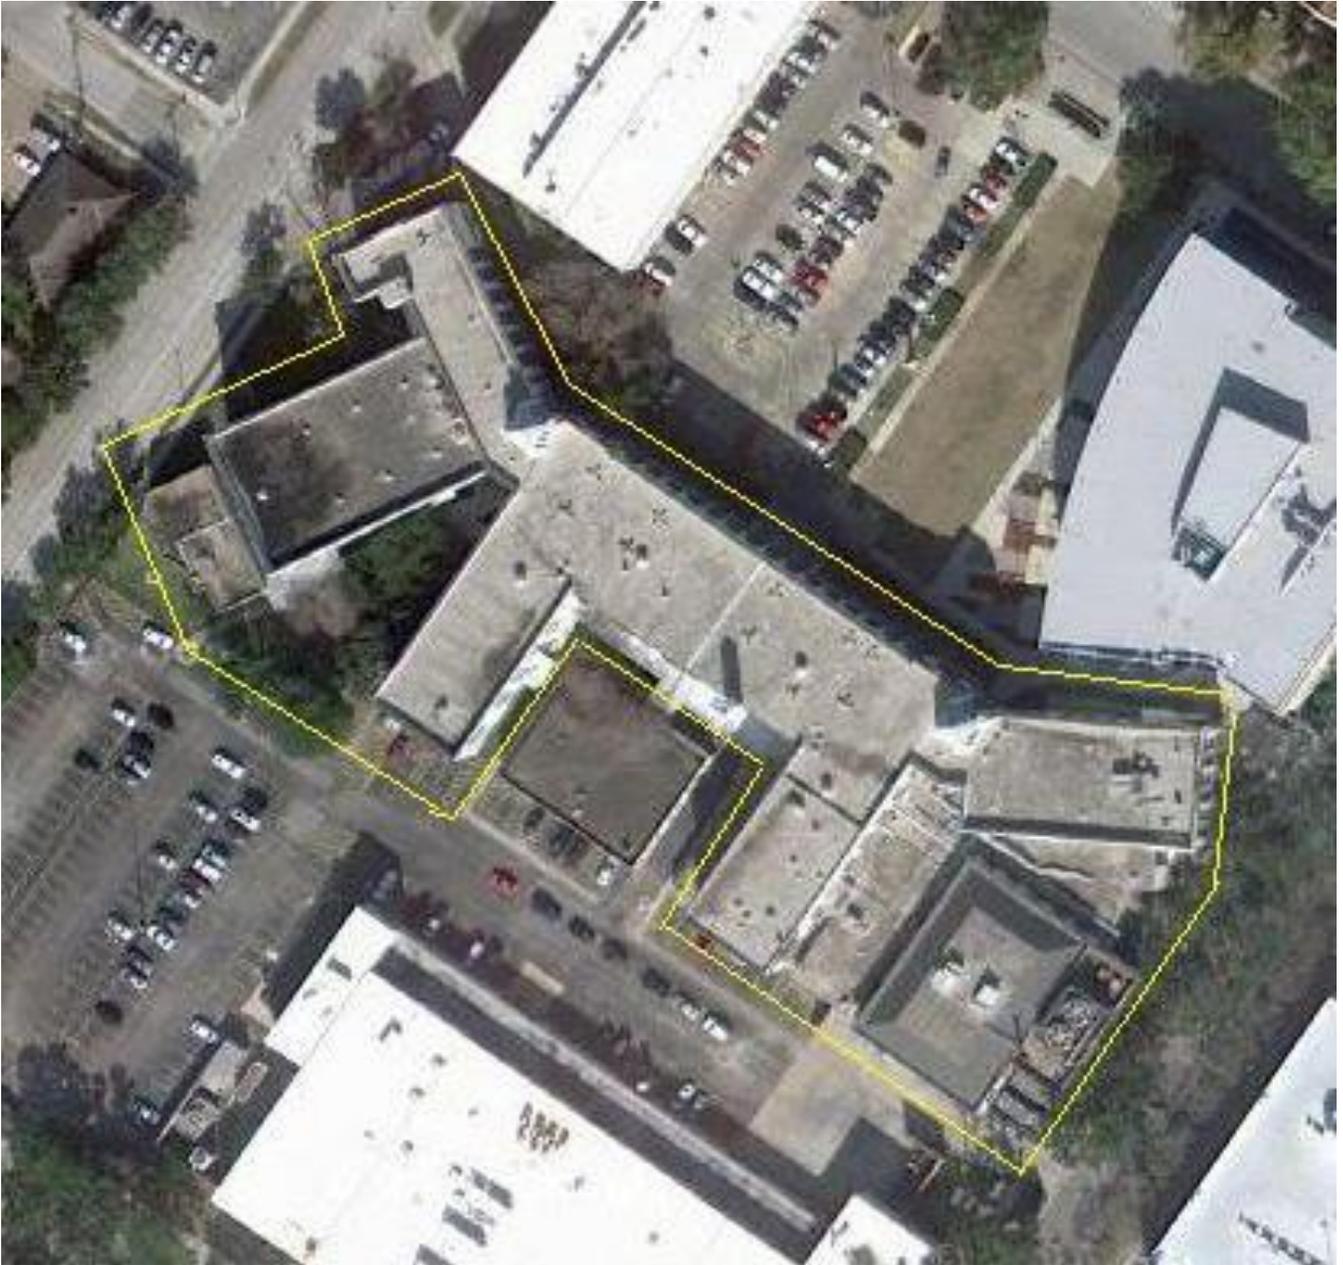
Building Site Plan Photo

San Jacinto Building Inspection Area is Outlined in Yellow
